Jetty Repairs cope with time and tide

The repair of a concrete jetty on the estuary of the River Severn, where the tides are phenomenally high, presents a special type of challenge. **Jack Barfoot** talks with the contractors, Colebrand Contracting Limited.

Built in the sixties, the trestle type reinforced precast concrete jetty supports and gives service access to a pylon standing away from the shore immediately downstream of the Severn Bridge at Aust in the County of Avon.

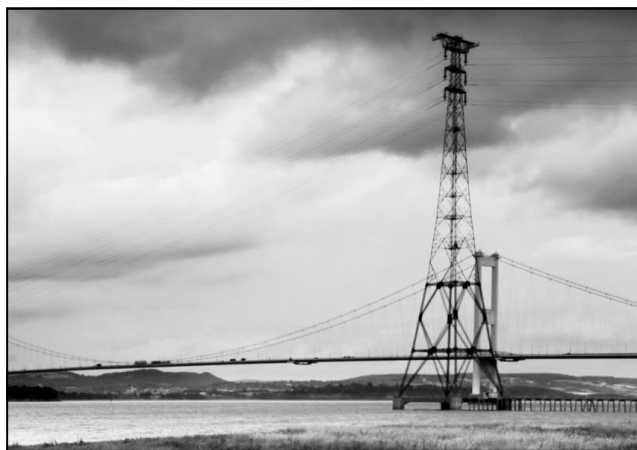
Work comprised patch repairs to the trestles, together with repairs to, and extending the cover of, the insitu concrete plinths at the base of the trestles.

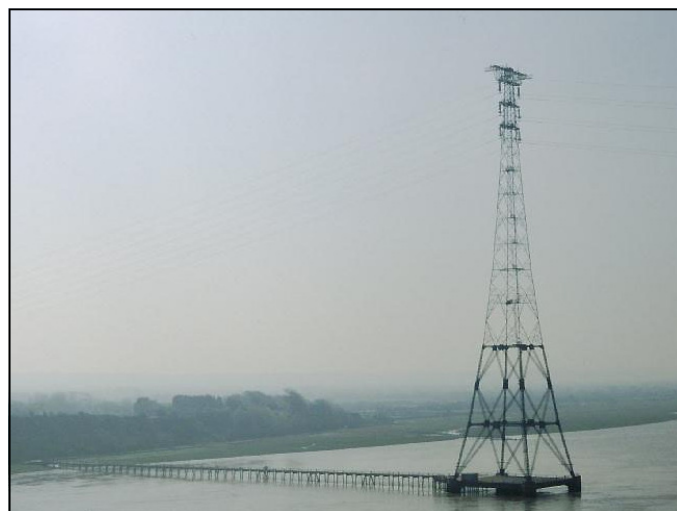
Phil Stainton, who was in overall charge of the contract, and Chris Walton, Manager of the South Wales office and Contracts Manager on a major maintenance contract on the neighbouring Severn Bridge, described the contract and its relevant aspects to me. "The repairs themselves were fairly orthodox although the length of defective concrete repaired at any time on a trestle leg was confined to 2 metres, and on no more than 2 of the 4 arises, in order to minimise the reduction of the structural integrity of the trestle during the repair procedure. We used **Nufins Nupatch** proprietary fast setting mortar and concrete repair system, and the general procedure was that of traditionally cutting back any damage as far as the reinforcement, which was then grit-blasted to bright metal and primed with a Colebrand material, CXL 111. Then using a timber shutter, the repair material was poured in from the top, vibrated and left to set, which took about an hour to achieve".

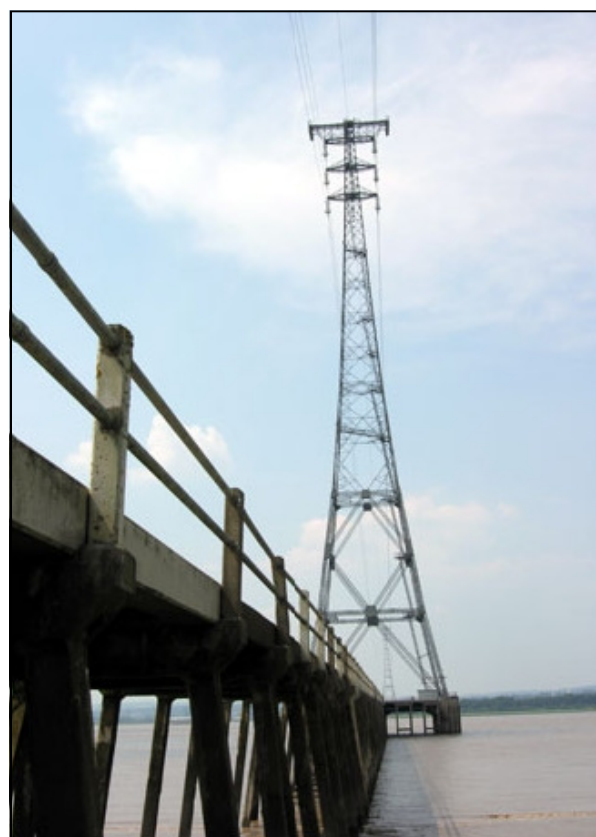
“The plinths, or bases, to the trestle legs constituted the most difficult part of the work. Some of these had deteriorated quite badly, as might be expected from their situation. After digging away the surrounding mud, cutting out the defective concrete and affecting the normal repair procedure, we then recast and enlarged the affected plinths to give increased cover and protection to the reinforcement”. This consisted generally of adding 150mm of concrete to all the one-metre-square faces and tops of the plinths, and included drilling and fixing resin-anchored dowels to assist in providing a bond between the old and new concrete.

“The plinths were submerged for most of the time” Phil Stainton recalled, “particularly at the far end of the jetty, where we could only work on them during spring tides when the water was at its lowest ebb level. Even then only a limited amount of time was available in which to place the material and allow to set. Once the initial set has taken place **Nufins Nupatch** is not affected by immersion”. He added, “Which is why it was chosen for this job”.
