Pumped Grout - Whitburn Coastal Park, Mill Lane, South Tyneside

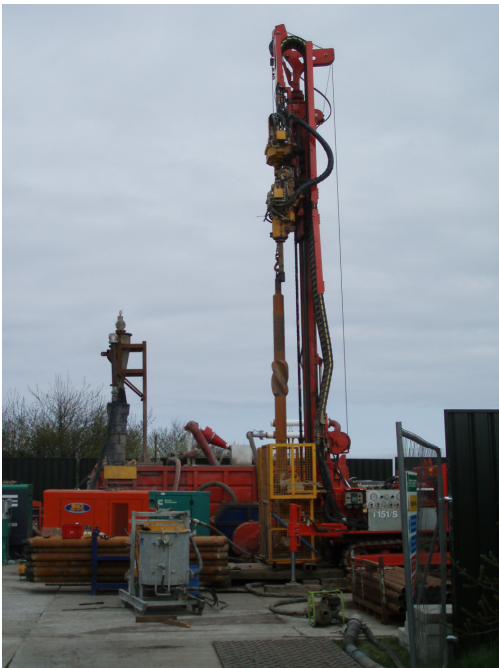
A mud-slurry drilling contract for the Coal Board - to sink a bore hole for monitoring water levels in mine shafts - hit problems at 10am on May 4th 2010. At a depth of 30m the rock strata was fissured, leading to the unwanted disappearance of the mud-slurry used in the drilling operation! Nufins were contacted to meet with the contractor the same morning and to specify a suitable fast setting product that could be pumped in to plug and seal off these fissures.

The pour commenced at 4pm and by critical control of water addition and observation of the product workability, we successfully pumped approx 2m³ of bagged grout in 2.5 hours, filling the borehole upwards from 30m to 11m deep. This effectively stopped the downtime on the operation. As the grout *bodied-up* and hardened, all leaks were plugged and the mud-drilling process was recommenced after 12 hours the next morning.

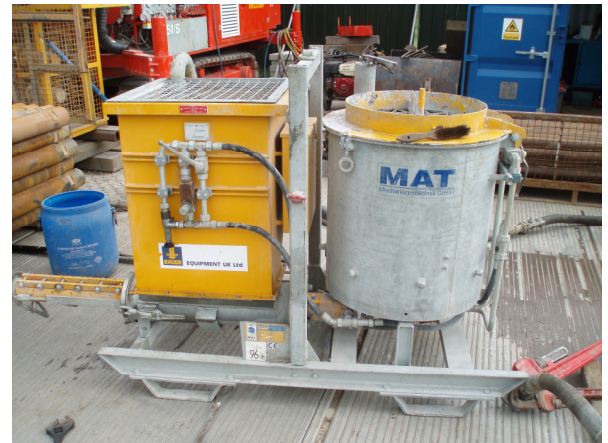
Due to the nature of the operation, our technical team specified a choice of two materials which were sent to site that afternoon. First selected was **'Nugrout Flowable Concrete'** which is best pumped through a Putzmeister P11 worm drive pump, but since the contractor was unable to acquire such a pump at short notice and could only acquire a Bauer colloidal slurry pump (not primarily designed to pump micro-concrete), we proposed to revert to the other selected option of **'Nugrout Hispec'**, a pre-bagged free flowing pourable and/or pumpable grout.
