Doncaster Repairs

An extensive range of improvements has been made to the existing Southern MSCP to provide car users with a safe and secure parking experience. The works ensure that the building fits into its new environment in this new quarter of Doncaster.

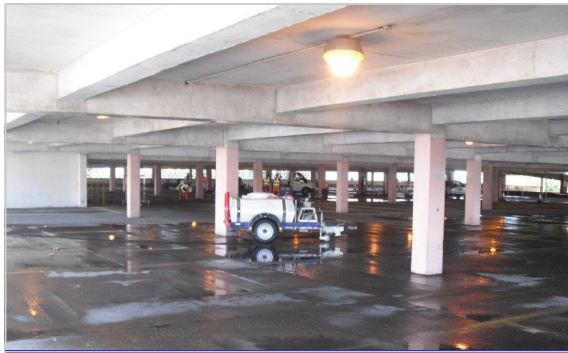
Before

The concrete parking levels were repaired and treated to safeguard against future corrosion and there was an extensive repainting program.

Works undertaken by USL included grinding the rough tamped concrete to improve the finish. Protectosil corrosion inhibitor was then applied to all of the concrete decks. In the running isles the appearance of the concrete was then further enhanced by applying Mastertop 524 to provide a smooth finish. Conideck waterproof wearing surfacing was then applied throughout the car park decks. The appearance of the finished decks is excellent and the difference to the existing decks is dramatic.

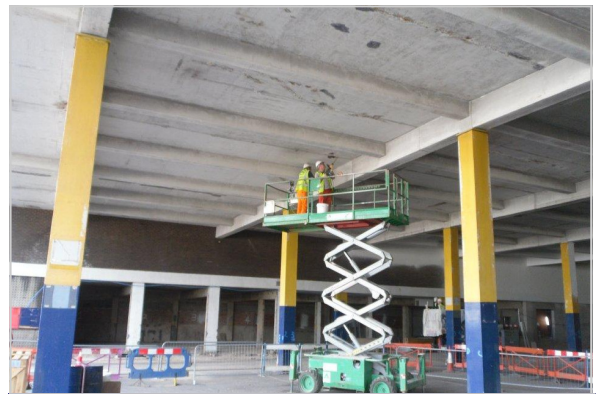
Before

The repairs to the soffits and walls was undertaken using Nufins HB mortar, with Nucem mortar applied to the concrete decks. Prior to doing this all the surfaces were power washed as the car park was covered in decades of grime. Once the concrete repairs were completed Nufins covercrete anti carbonation paint was applied providing a bright finish to the car park.

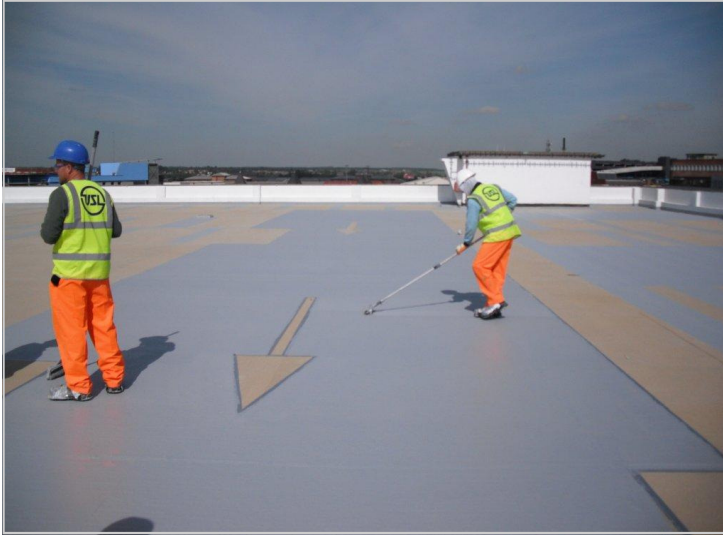
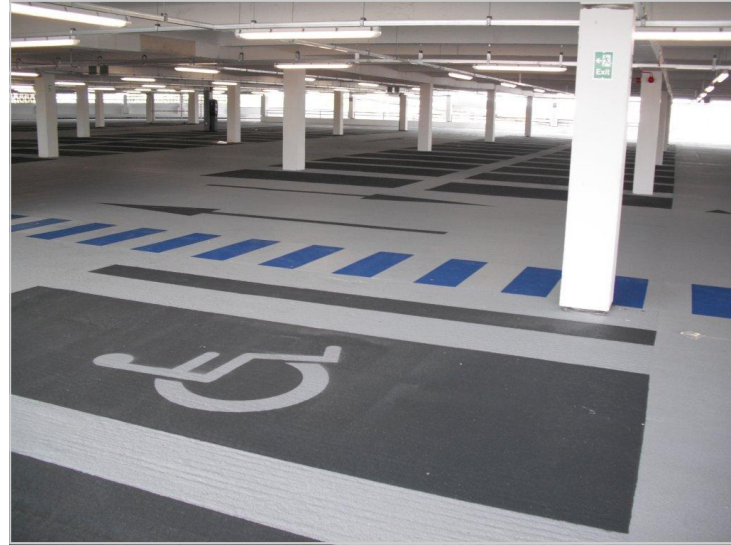
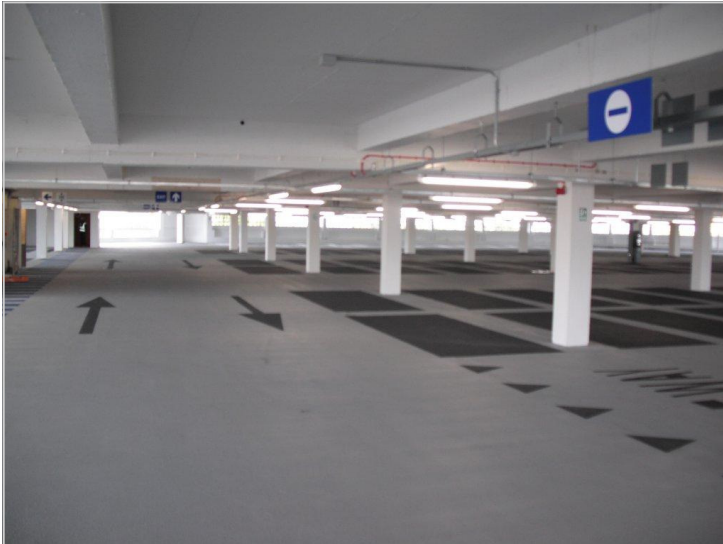
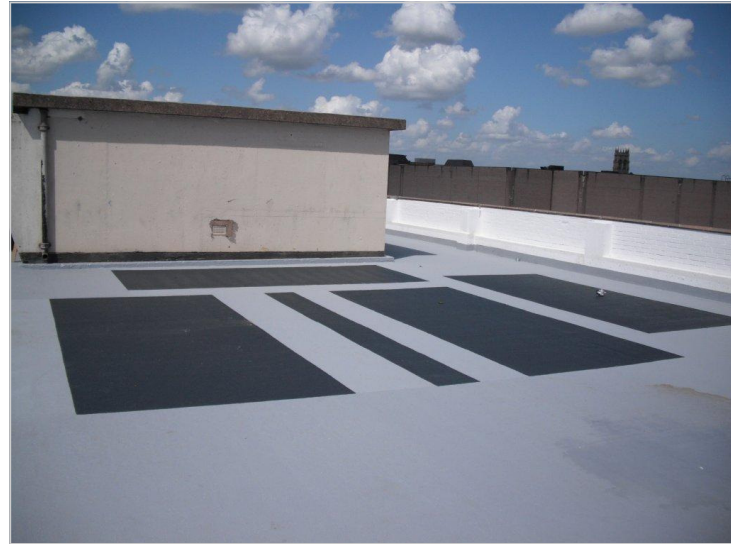
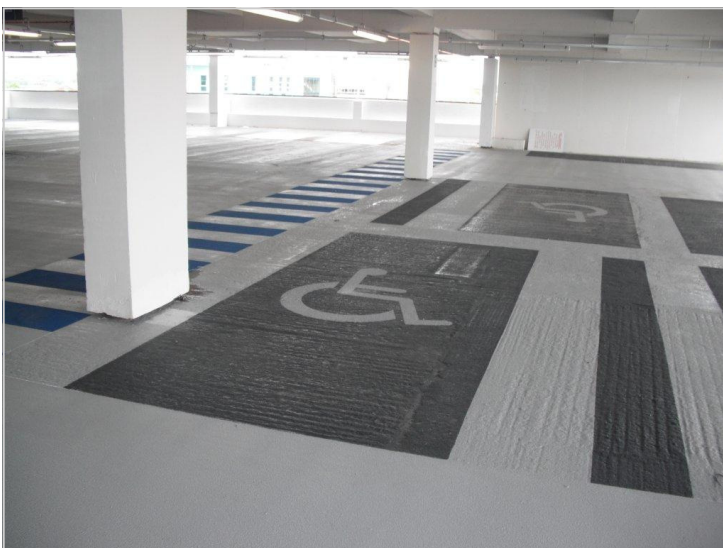
See page 2 for more application photographs
