# The Mall, Walthamstow

**The Mall at Walthamstow provided a project that incorporated a large-scale refurbishment of a covered car park lying below a major suburban shopping centre. The original car park design meant that there was very little natural light allowed into the car park. Also, the single suspended parking deck was large scale, resulting in various people having difficulty locating their vehicles when returning to their cars.**

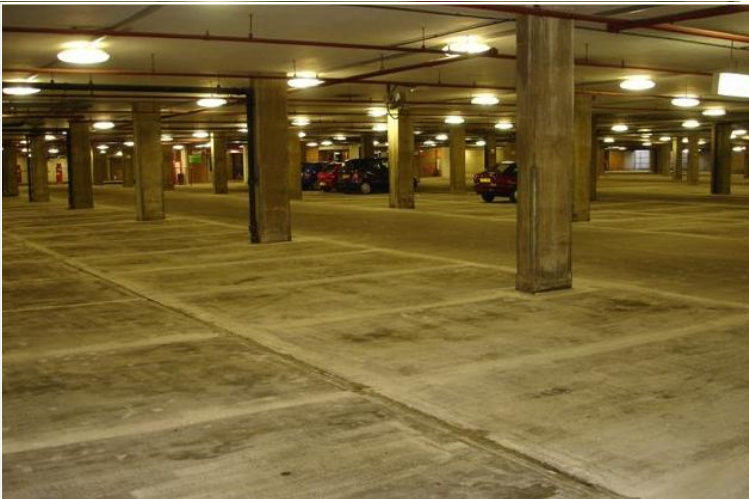
The concrete car park deck was untreated, and the walls and columns unpainted leaving an uninviting environment for the shoppers. The decks and walls were unattractive concrete.

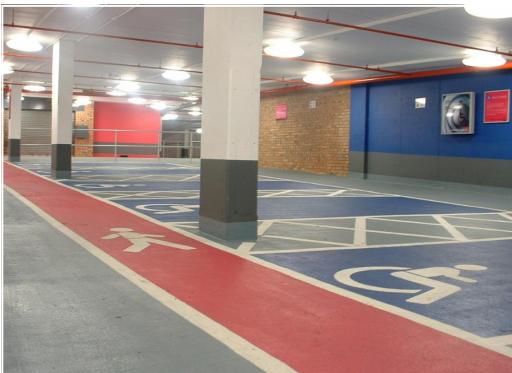
To overcome these problems USL StructureCare applied a colour coordinated parking system, allowing visitors of the Mall to easily recognise the area in which their vehicle was parked. This colour system included the unusual task of painting brickwork as well as concrete walls in order to section the car park off into different colour coded parking areas.
